MEMORANDUM

DATE: DECEMBER 13, 2021

Subject: Surface Expression, Pacific Coast Energy Company LP, 9151 West Pico

Boulevard, Los Angeles, CA 90035

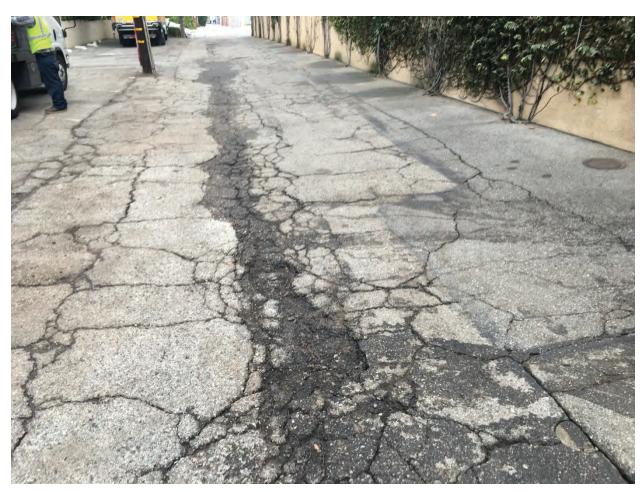
Figure 2. This photo shows the area affected by the leaked fluid. The fluid pooled in the center of the alley and travelled west down the alley. It was reported that the fluid was removed with absorbent material and the ground was steam cleaned. At the time of the photo, there was no oil present. What is seen here is staining. There are no sewer or drainage systems affected. Visual staining was present on the alley surface.

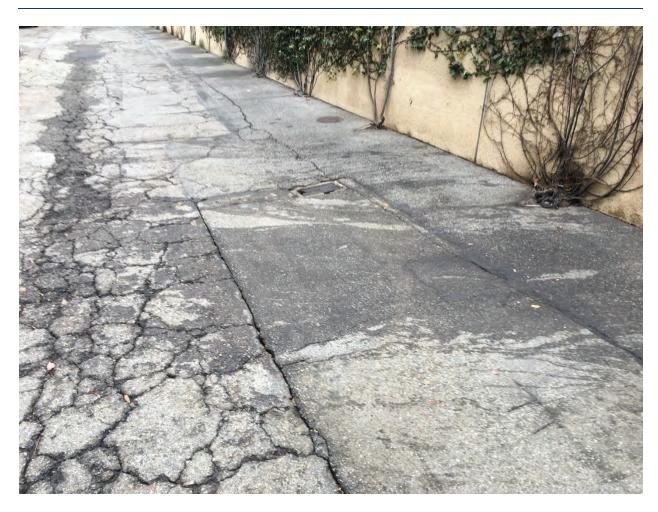
Figure 3. Staining shows point source with most discharge as well as lateral extent into the alley

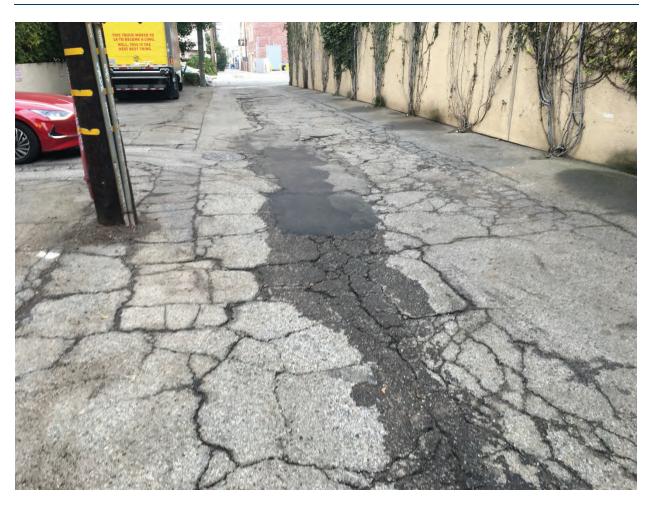
Figure 4. Shows areal extent of leaked fluid migration

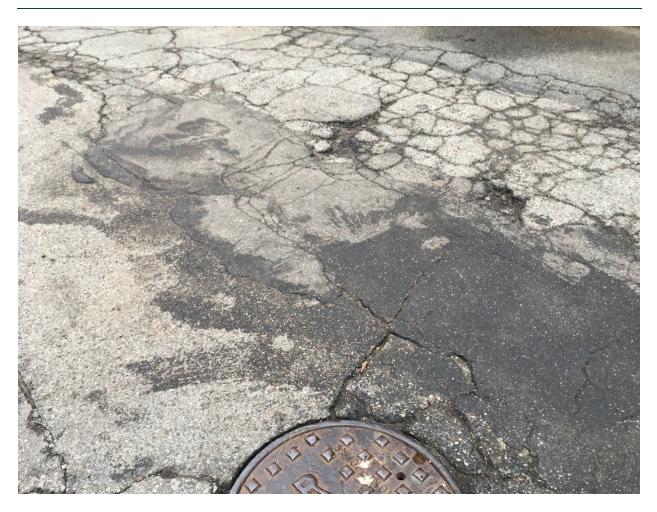
Figure 5. shows leaked fluid migration extent

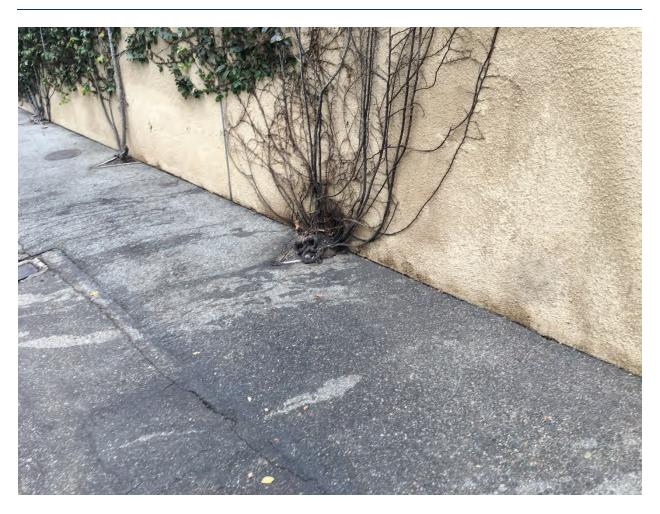
Figure 6. The fluid was extruded through the joint where the building wall met with the asphalt alley. The area shown here was the main location of leaking with minor leaks further east and west in the photo. The area which had leaks was approximately 10 feet in length.

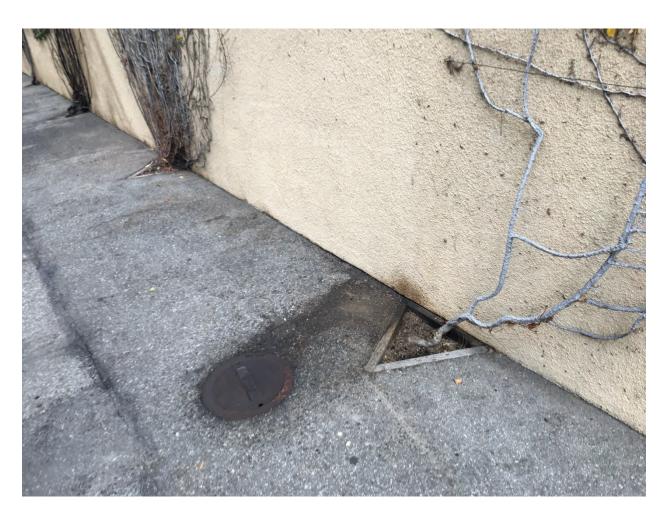
Figure 7. The leaks were in between these four vines pictured.

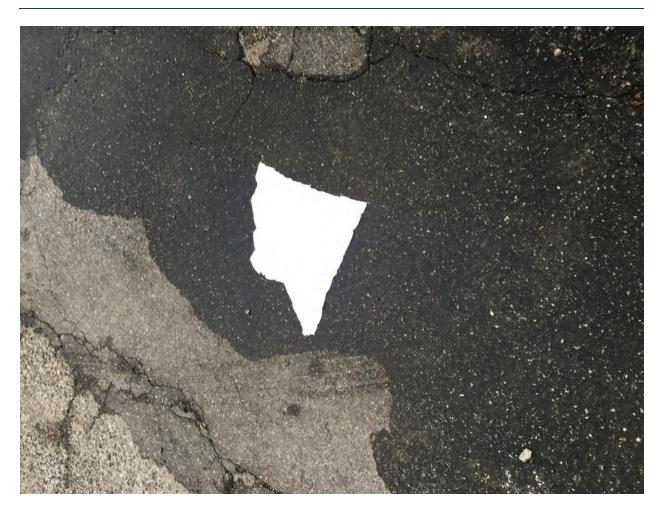
Figure 8. This photo was taken before the rag was stepped on to show that there was no longer any leaked liquid present.

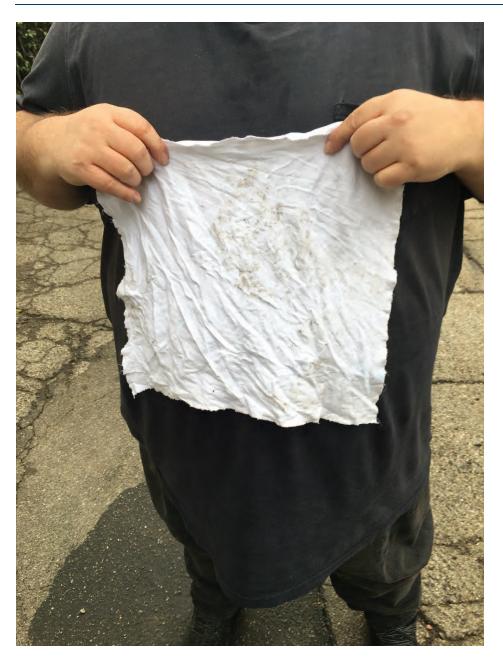
Figure 9. The rag was examined by J. Athanasious and did not show any evidence of liquid absorption.

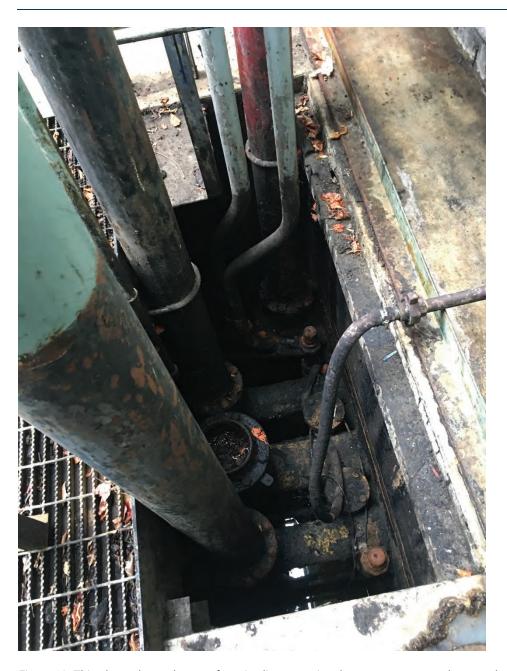
Figure 10. This photo shows the out of service lines entering the cement to run underground to the production facility. The two 6-inch lines were still connected to the pressurized pipeline system but isolated with a "slip blind" that failed.

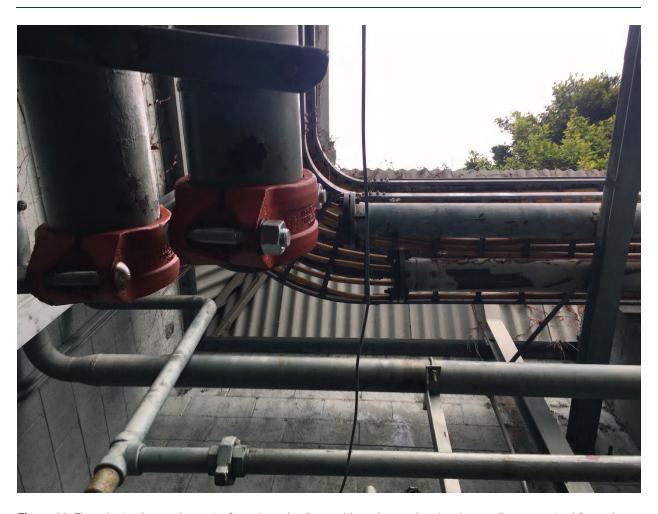
Figure 11. The photo shows the out of service pipelines with red caps having been disconnected from the horizontal pipelines that are still under pressure. At the time of the leak, these two ends were connected and the out of service segment was isolated from pressure with the use of a "blind slip" that was found to be corroded to the point of leaking.

We then entered the production facility where the failed slip blind and out of service portion of the pipeline that was determined to be the source of the leak was located (Figures 11-13). Inside the production facility, I observed the pipeline as having sections of pipe removed and ends capped to prevent further future releases (Figure 12).

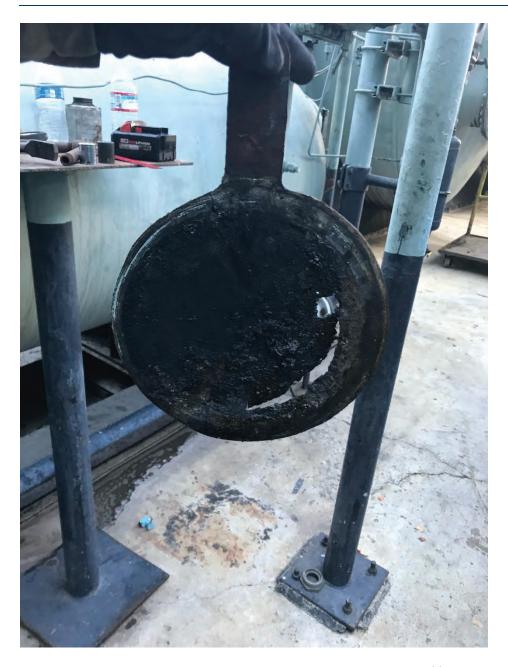
- The out of service pipeline was still physically connected to the in-service, pressurized pipeline system at the time of the incident.
- The out of service pipeline was isolated by use of "slip blinds".
- The slip blind was removed and had visible corrosion and full failure of structural integrity.
- The failure of the out of service buried line, buried below the surface expression
 of the leak was not determined at the time of my visit.

Figure 12. This picture shows the corroded blind slip that was the root cause of fluid entering the out of service pipeline that is buried near surface expression of the leak in the alley.
